**NIOSH**  
Fire Fighter Fatality Investigation  
and Prevention Program

A summary of a NIOSH fire fighter fatality investigation

## A Career Captain and a Part-time Fire Fighter Die in a Residential Floor Collapse—Ohio

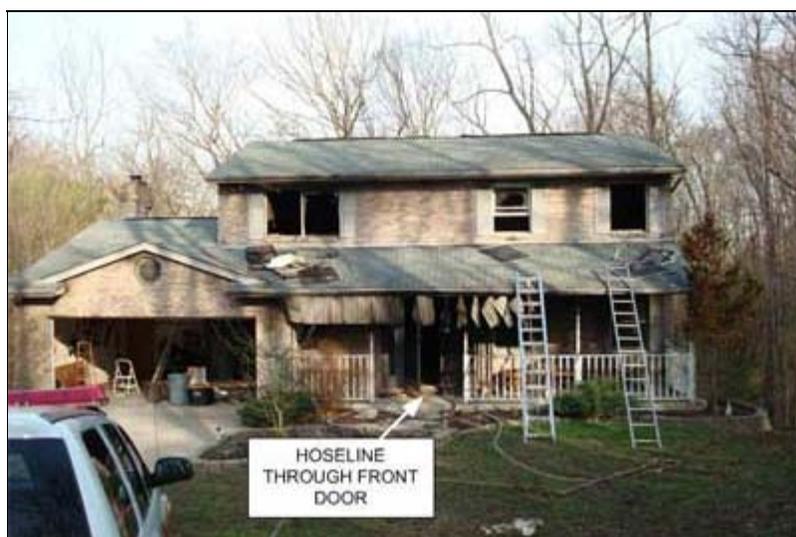
**Photo 1. Fire structure, a two-story single-family residence (A-side). The 1<sup>3</sup>/<sub>4</sub>" hoseline is shown lying in the yard and going through the front door.**  
*(NIOSH photo)*

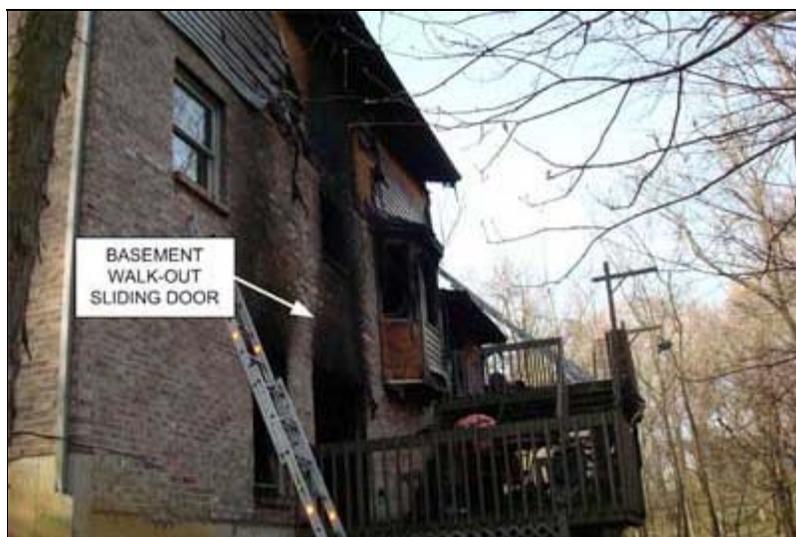
**Photo 2. Fire structure showing rear (C-side) ingress and egress points on two decks.**  
*(NIOSH photo)*

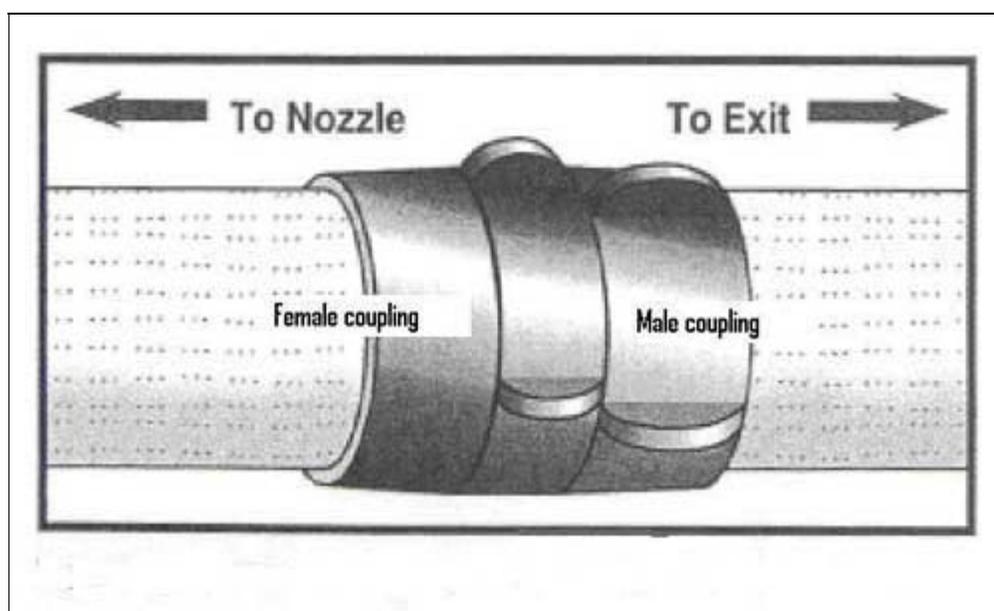
**Diagram 4. Hose couplings will indicate the direction toward the exit.**  
Adapted from IFSTA *Essentials of Fire Fighting*, 5th Edition

There are a number of ways that a hoseline can be marked to indicate the direction to the exit, including the use of raised arrows and chevrons that provide both visual and tactile indicators. Fire departments may use a variety of techniques to train fire fighters on how to identify hoseline couplings and the direction to the exit, based on the model of hose used by the department. The key point is that **this training needs to be conducted and repeated often** so that fire fighters are proficient in identifying the direction to the exit in zero visibility conditions while wearing gloves, with the hose entangled, and with various obstructions present. This procedure should be incorporated into SOPs, trained upon, and enforced on the fireground.

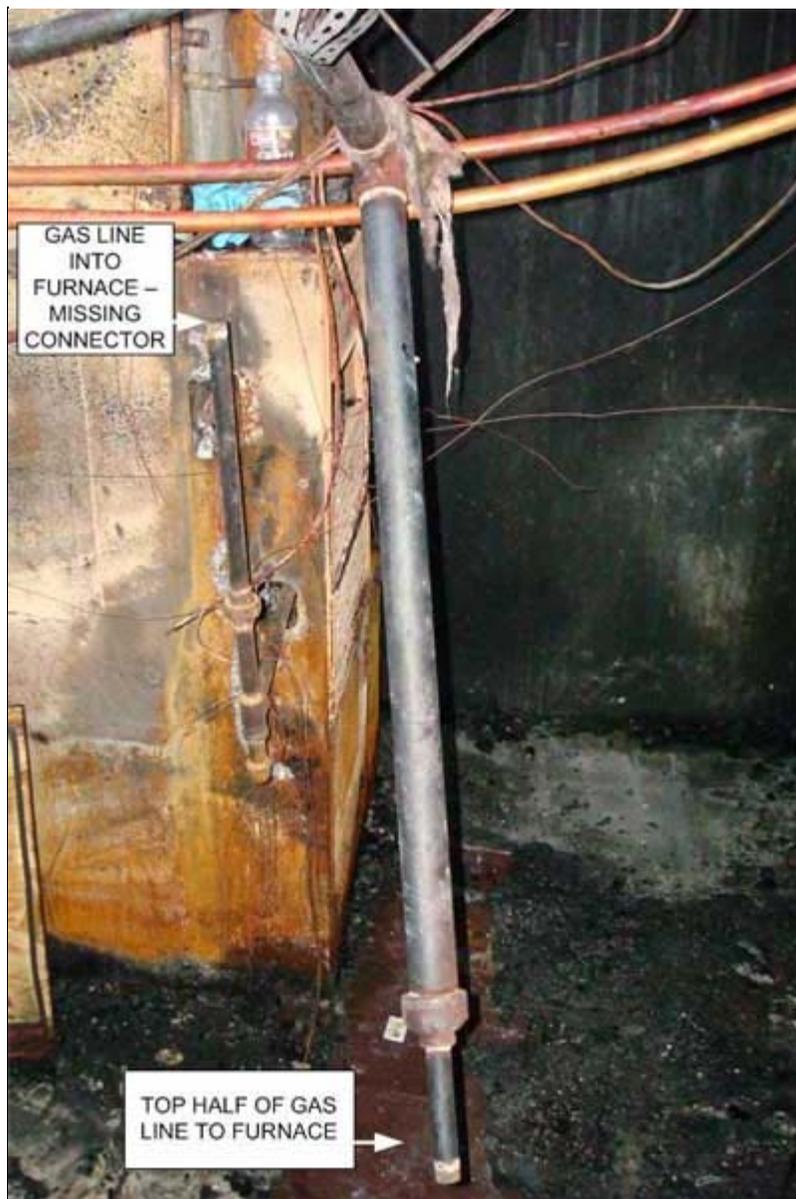
The home had natural gas forced air heat. During the investigation, it was noticed that the gas line (standard black iron pipe) to the furnace was missing some type of short connector (see [Photo 3](#)). The upper section of the main gas line in the house was weighted down from the collapse. When the pipe was at its original height a connector (approximately 2") was missing. The pipe threads on both remaining ends of pipe were relatively clean. If the missing connector was made of a flammable material it would have been completely destroyed during the fire. Unfortunately, there was not enough information to speculate what type of connector was missing.

**Photo 3. Gas line to furnace. Part connecting top line (end near floor) and line into furnace is missing. (NIOSH photo)**

***Recommendation #6: Fire departments should ensure that SOPs for offensive operations are followed, such as cutting utilities to the fire structure.***

In this incident, the fire structure's utilities, both gas and electric, were not shut off or cut until approximately an hour after the fire department's arrival. At 0630 hours, the utility company was contacted, but they did not have an estimated time of arrival. During RIT operations a blue flame was noticed near the D-side of the collapsed area indicating a possible gas-fed fire. At 0654 hours, the RIT crew radioed a possible natural gas-fed fire.

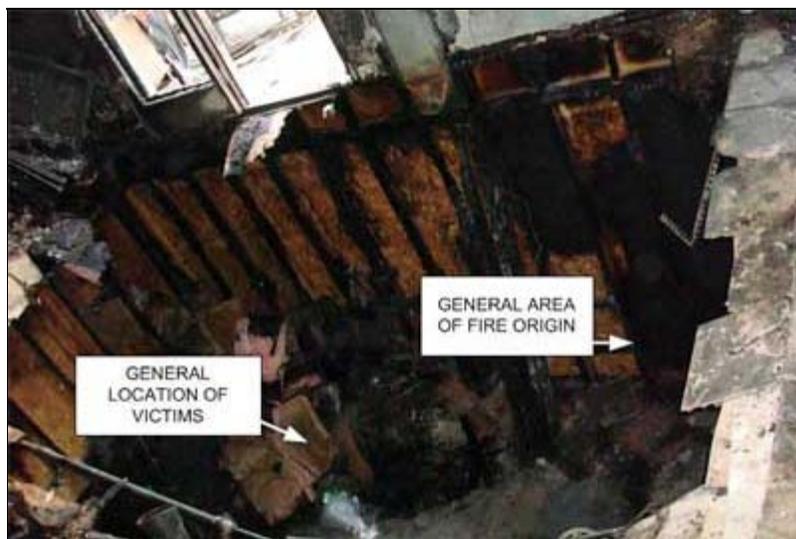
At 0708 hours, after moving some debris, Victim #1's SCBA was exposed near the B/C corner of the basement. It was determined that the victim was dead on the scene and C#3 told the crew not to move the body. The IC was informed of the location of the body and after some discussion Victim #1 was placed in a stokes basket. At 0729 hours, upon moving Victim #1 and some debris, Victim #2 was located underneath Victim #1 (see [Photo 4](#) and [Diagram 1](#)). Victim #2 was also dead at the scene.

The victims exited the basement from the heavy smoke and heat by way of the basement stairs to the first floor. On the first floor, the captain (Victim #1) tried to transmit on the radio and informed FF#1 to get out. FF#1 exited the structure alone following the hoseline. It can only be assumed that the captain (Victim #1) and the fire fighter (Victim #2) became disoriented or felt that the quickest escape from the heat was diagonally across the room to the atrium door (see [Diagram 2](#)). This path was above the seat of the fire which had severely damaged the structural integrity of the floor and collapsed.

**Photo 4. Collapsed section of floor the victims crawled across and the approximate location of their bodies in the basement.**

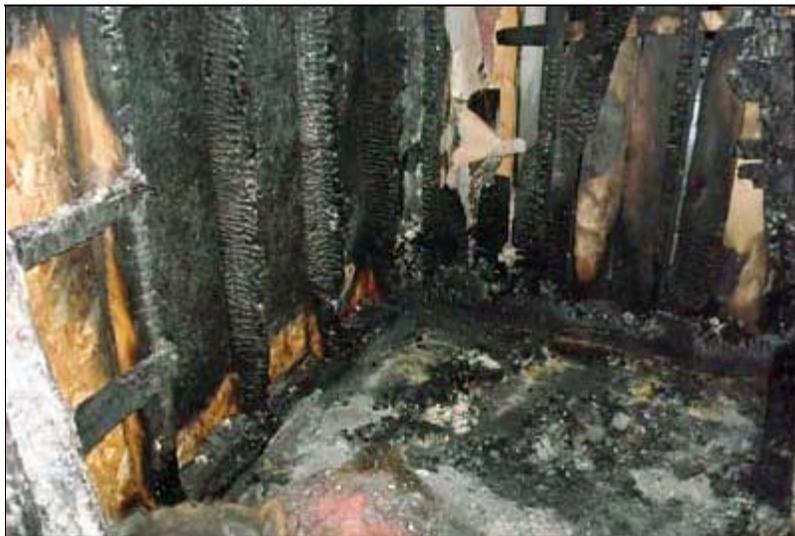
The fire department's report stated that the fire was caused by an electrical short in a fan located in a small cedar closet used to cultivate orchids located in the basement (see [Photos 5 and 6](#) and [Diagram 1](#)).<sup>1</sup>

**Photo 5. Origin of the fire: small cedar closet used for growing orchids.**

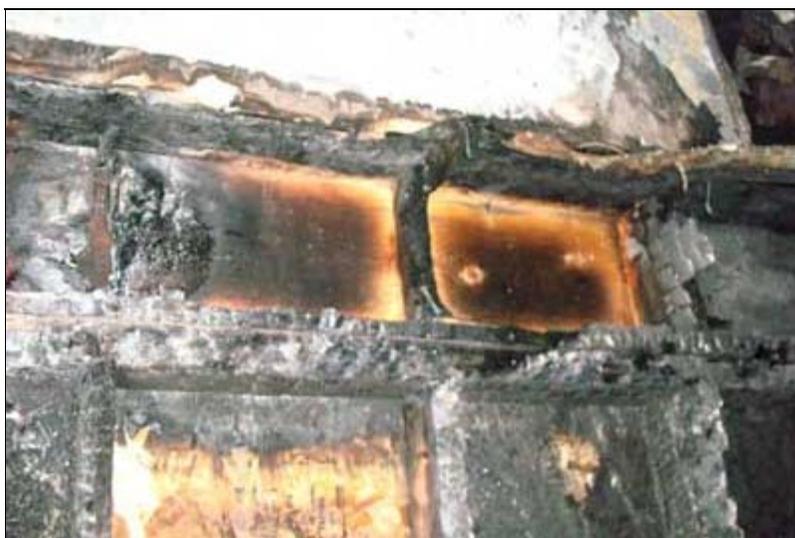
According to the fire department's report, an electric fan shorted, causing the fire. The fan was located in a small cedar closet, along the C-side wall about 14 feet from the B/C corner (see [Photo 5](#)). As the fire extended up the C-side basement wall, the first floor 2"x10" wood floor joists were directly impacted by the fire and heat (see [Photo 6](#)).

**Photo 6. Burned away floor joists above the small cedar closet along the C-side wall.**

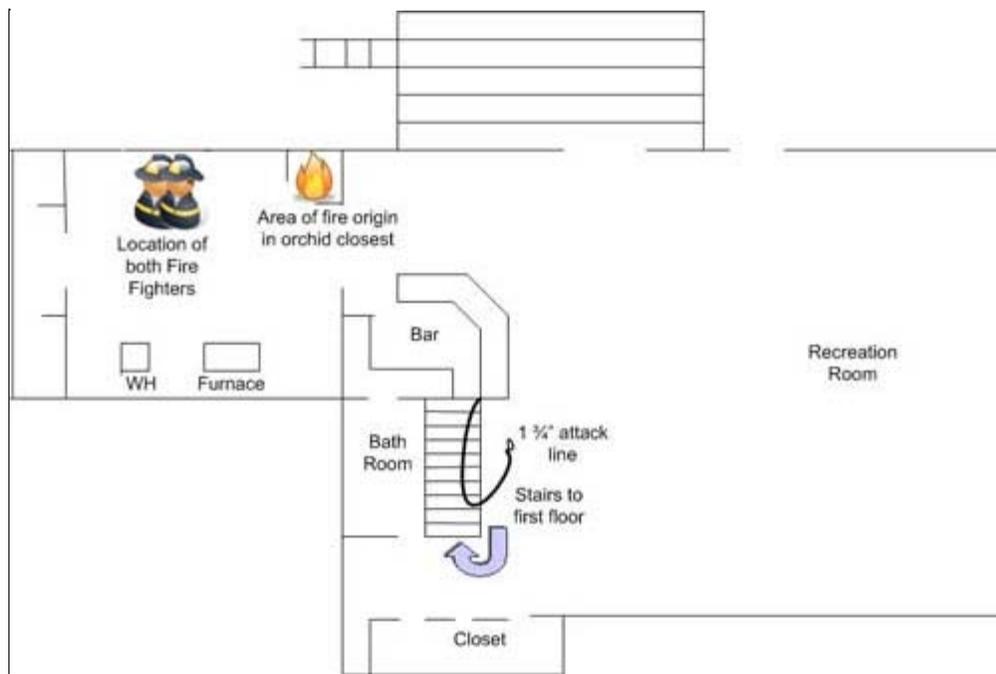
**Diagram 1. Layout of the basement with approximate location where the victims were found and seat of the fire.**

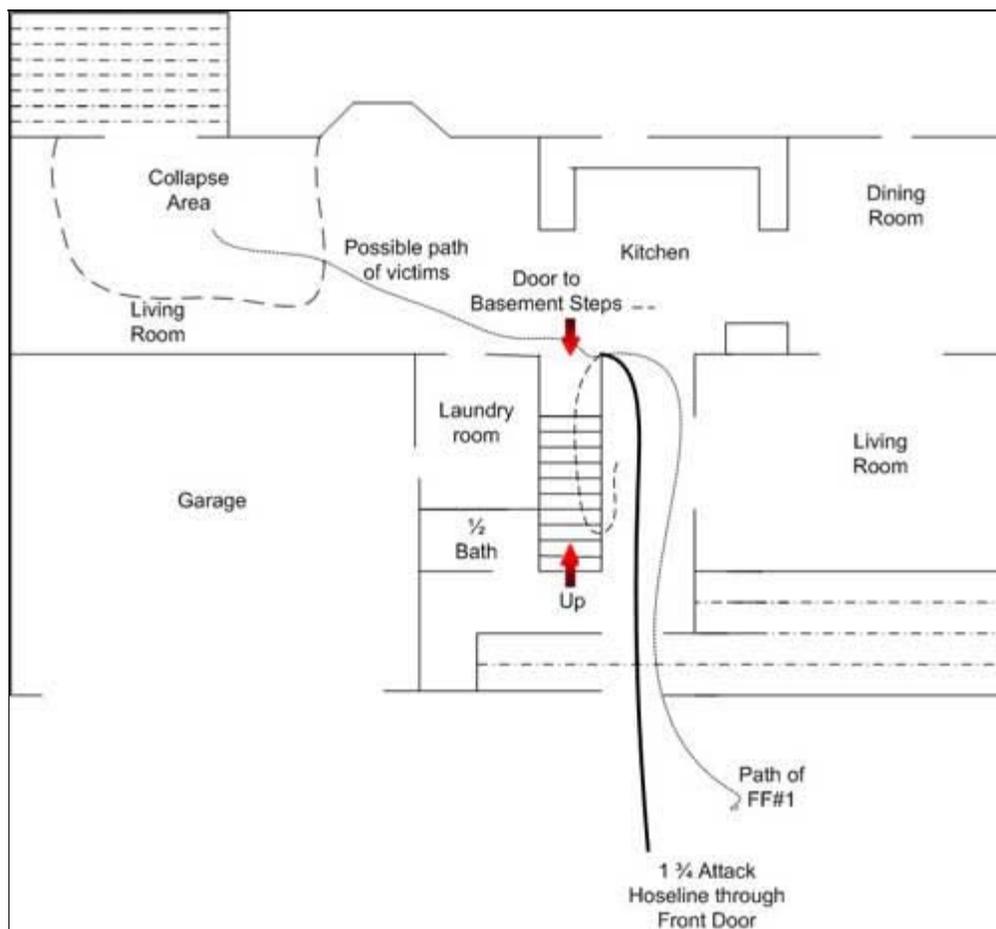
**Diagram 2. Fire structure's first floor layout:**

**Possible path of interior crew when the captain  
(Victim #1) told FF#1 to get out at basement stairs door.**

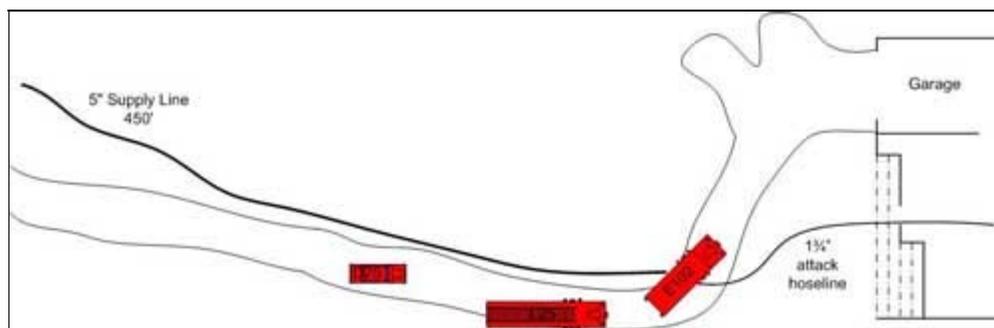
The home was near the bottom of the hill resulting in a 450-foot driveway to the main street where a fire hydrant was located (see [Diagram 3](#)).

**Diagram 3. Location of key fire apparatus and 1<sup>3/4</sup>" attack hoseline from E102 into front door.**
